Manhole Inspection Summary

Manhole # S25EE1007MH

Insp Date: **1/24/07 9:37 AM**

Location Address: **3970 EDGEHILL AVE**

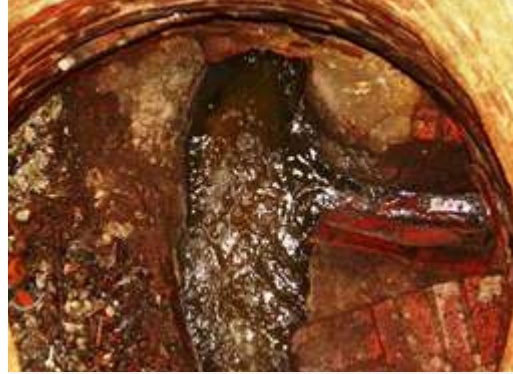
Top View

Evidence of surcharge - Bench debris.

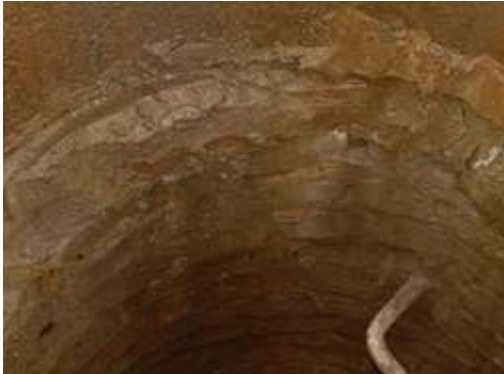
Defect

Frame leaks. Adjustment infiltration.

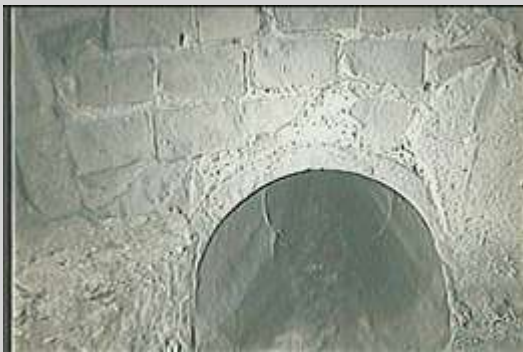
10 in. Circular Gravity Sewer Pipe Out @ 12 O'Clock

Barrel deterioration and infiltration.

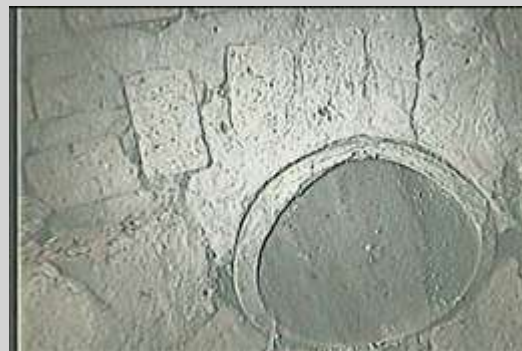
Drop In @ 3 O'Clock

Barrel deterioration, cracks and infiltration.

Infiltration: **Evidence** Pipe Seal Cond: **Cracked**

Drop Condition: **Partly Clogged**

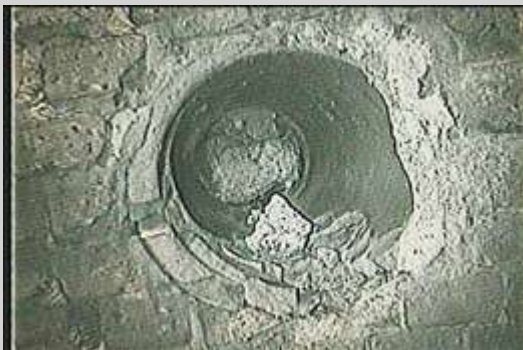
Pipe In @ 11 O'Clock

Barrel deterioration and infiltration.

Infiltration: **Evidence** Pipe Seal Cond: **Broken**
